**CORROSION OF DRAINAGE WELLS
AT SARDIS DAM, MISSISSIPPI**

TECHNICAL MEMORANDUM NO. 3-287

WATERWAYS EXPERIMENT STATION

JUNE 1949

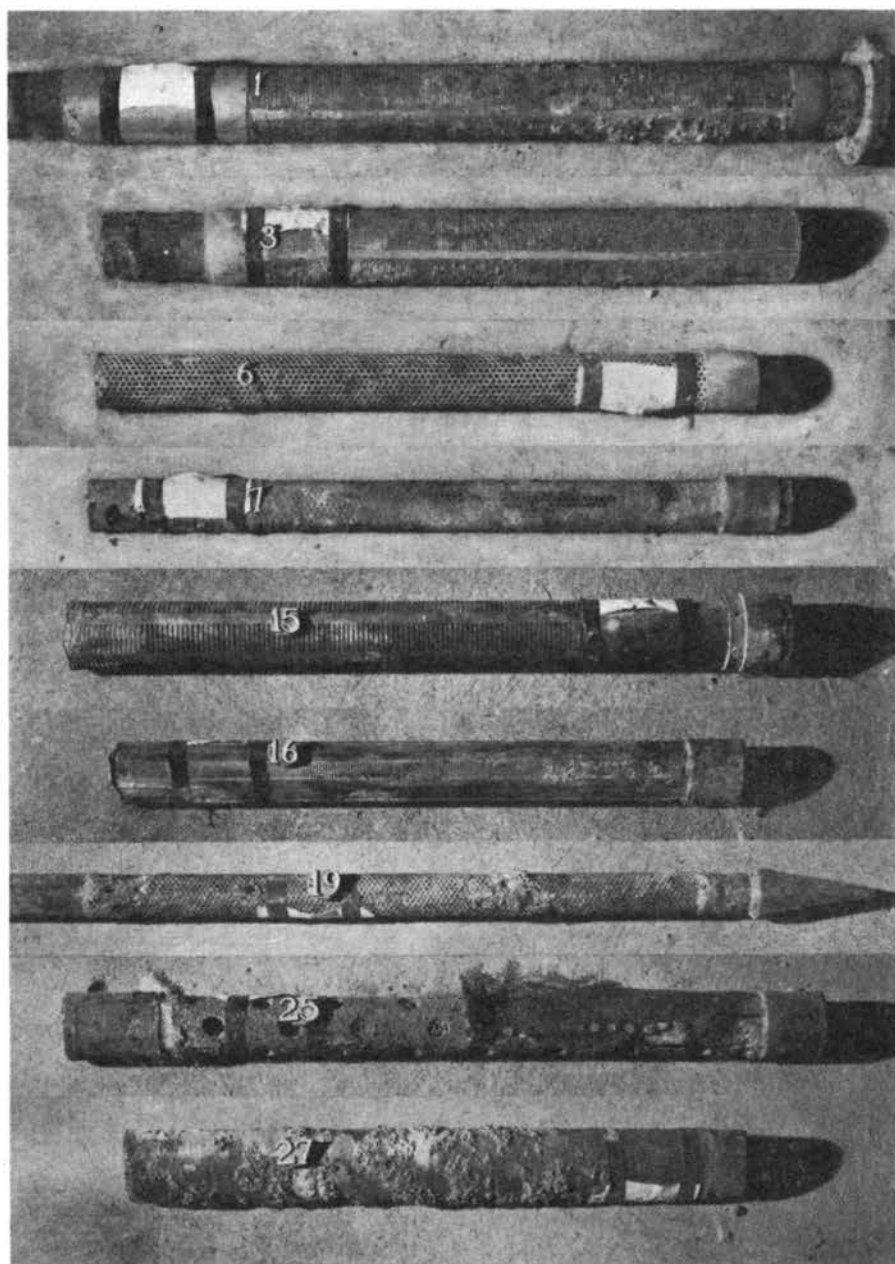
SARDIS DAM EXPERIMENTAL WELL SYSTEM
CORRODED WELL SCREENS

18. The photographs of plate 3 give a general indication of the corrosion which occurred in the brass and combined brass and steel well screens of the experimental system. Wells 1 and 3 of this system had screen sections which consisted of a perforated iron pipe core on which a tight helix of brass rod of trapezoidal cross section was wound over longitudinal spacers. Deposition of corrosion products on these well screens apparently restricted the openings critically. The screen of perforated brass on well 6 showed very little corrosion. The screen of well 7 was very badly clogged with incrustation and corrosion products, although there was no evidence of serious disintegration. The slotted brass screens of wells 15 and 16 showed a rough surface, which was found to be typical of the corrosion of brass at the south end of the original system, and some obstruction was evident in the finer slots in well 16. The screen of well 19, which consisted of a perforated iron pipe core on which brass screen and perforated sheet brass were wrapped, showed considerable incrustation. The deterioration of this well screen, which is evident in the photograph, may be in part due to the removal operations. The screens made of perforated iron pipe wrapped with fine-mesh brass screen, which were used in wells 25 and 27, showed considerable corrosion of the screen mesh, and incrustation and obstruction of the perforations in the core pipe were severe. Several well screens of the types which were included in plate 3 and described above were dissected on a diameter and are shown in section in plate 5.

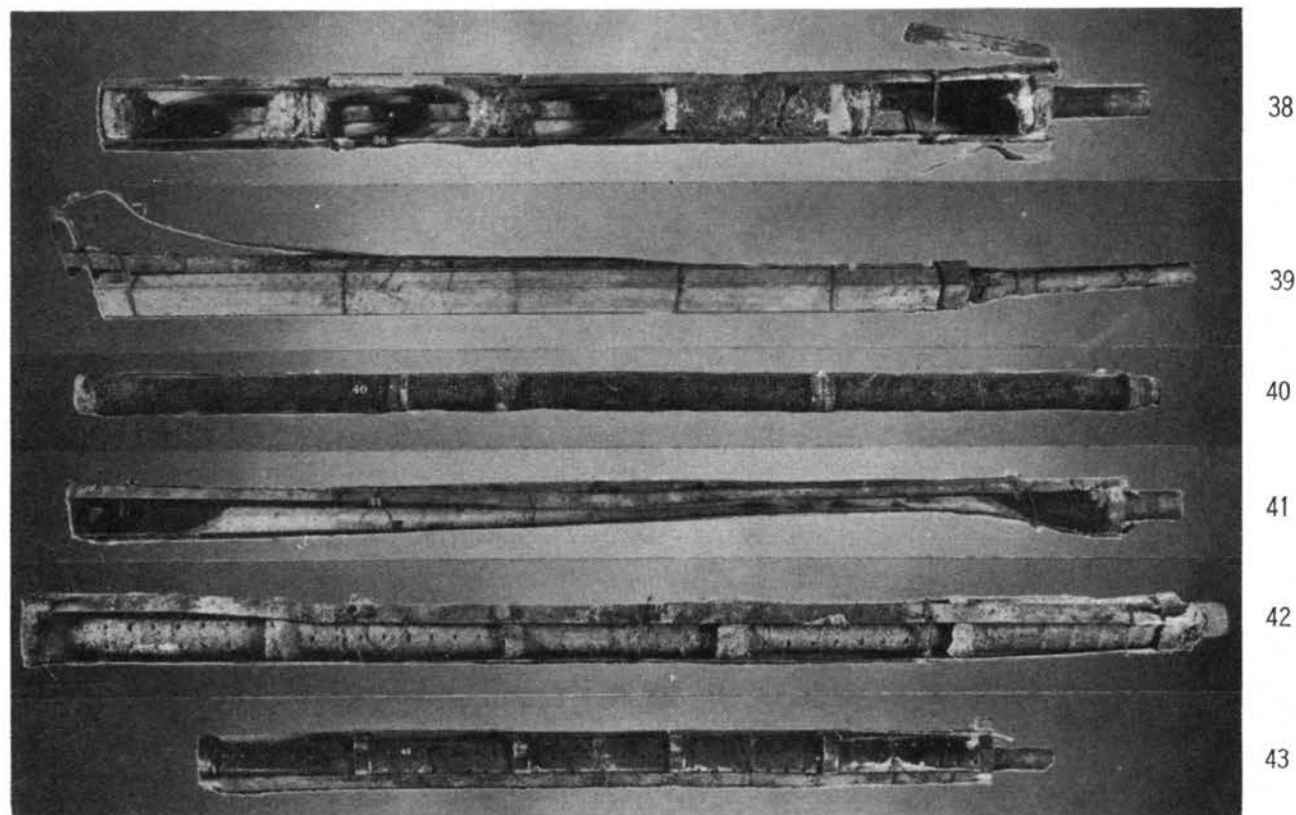
SARDIS DAM EXPERIMENTAL WELL SYSTEM
NON-METALLIC WELL SCREENS AFTER RECOVERY

19. The effects of exposure of nonmetallic well screens to the corrosive water of the Sardis Dam toe-drain system are illustrated by the photographs of the screen sections of wells 38 through 43 of the

experimental well system on plate 4. The porous concrete in both well 38 and well 41 disintegrated badly. Although some damage probably occurred during removal of the wells, a close examination of the remaining fragments indicated that chemical attack and leaching probably removed much of the cement and weakened the structure critically. The photographs indicate that the porous pipe of well 41 had either disintegrated or was lost nearly completely during removal and that only the nonporous joints of the porous concrete pipe of well 38 remained essentially undamaged in the screen section. The perforated square cypress screen of well 39 and the perforated vitreous clay pipe screen section of well 43 showed less damage than any other used in the experimental system. The gravel-pack well screen of well 40 showed considerable incrustation. Most of the gravel of this well screen was lost as a result of destruction of the cement binder by chemical attack and leaching. The perforated concrete pipe screen section of well 42 remained serviceable. However, the removal of an appreciable quantity of the cement by leaching and chemical attack exposed the aggregate and if continued at the same rate would have rendered the pipe unserviceable in a relatively short time due to enlargement of the perforations and weakening of the pipe walls.

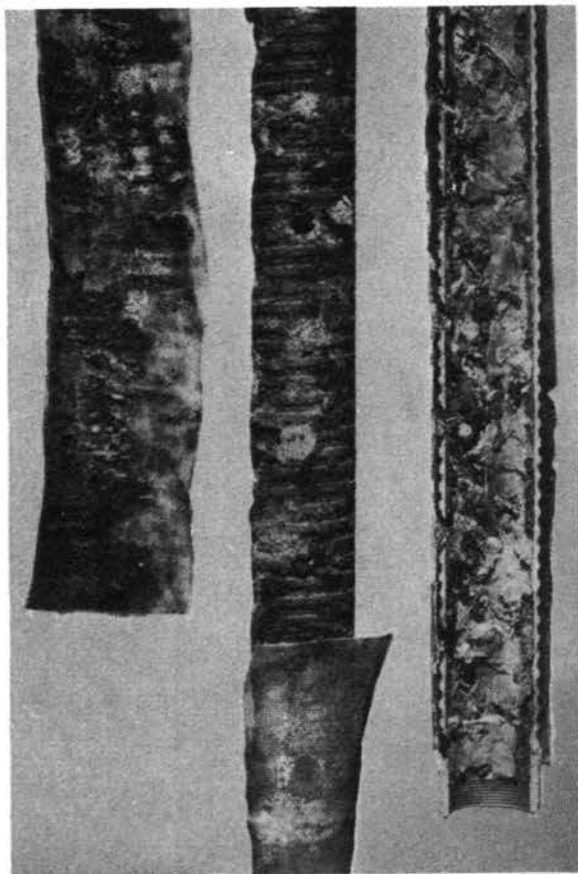
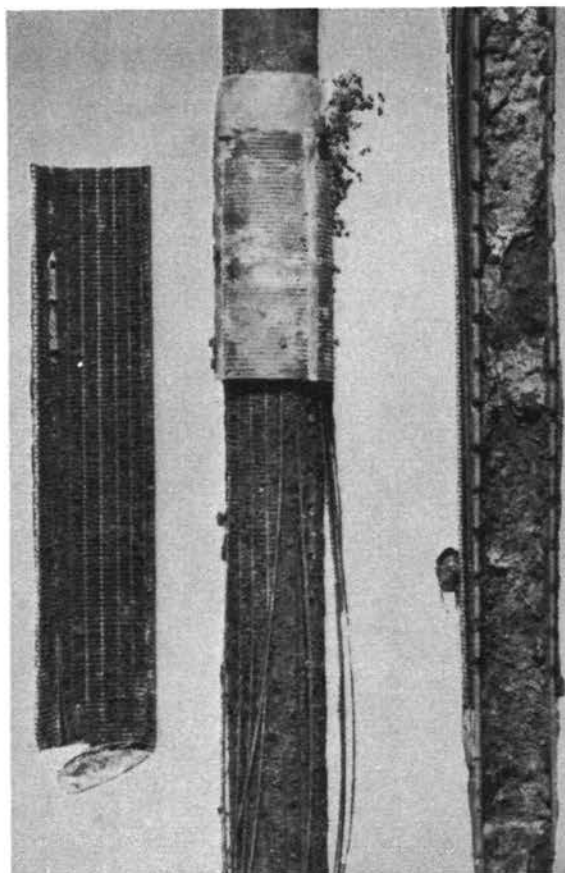
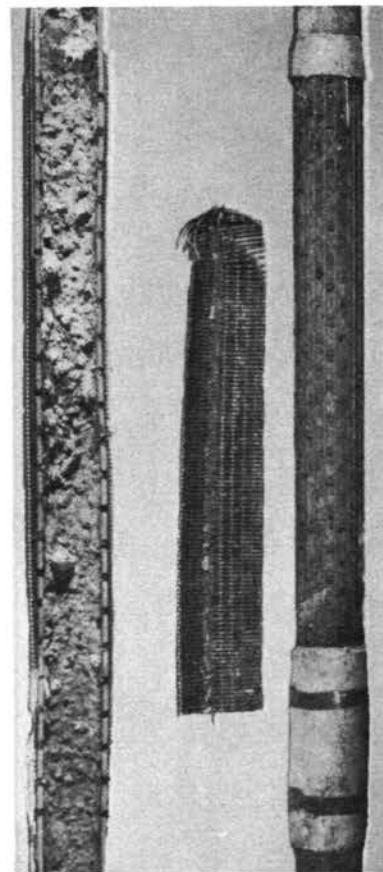
DISSECTED CORRODED BIMETALLIC WELL SCREENS

20. The incrustation and corrosion in the interior of the screens of wells 1, 3 and 27 are shown in the photographs of the dissected screens on plate 5. There is evidence of corrosion of the iron pipe cores of both types of screen with no indication of deterioration of the brass screening. Incrustation within the core and between the core and screen was heavy and interfered with flow into the well. Corrosion in these well points was evidently uniform with no indication of pitting or structural weakness.

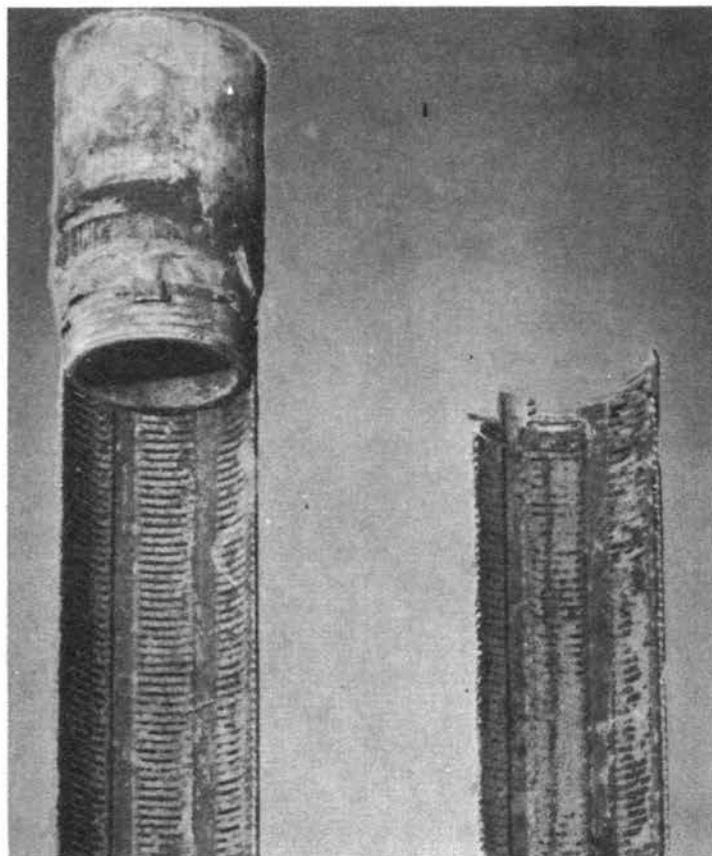
WELL 33

21. A portion of the slotted brass well screen from well 33 dissected on a diameter is shown in plate 6. There is evidence of some incrustation and deposition of fine-grained soil particles on the interior of this well screen. The important feature of the picture is, however, the evidence of disintegration of the slotted well screen in the vicinity of its connection to the threaded bronze pipe nipple by means of which it was connected to the riser pipe. This condition was relatively common in the wells toward the south (low-numbered) end of the experimental well system. A dissected portion of the cement-asbestos well screen and metal riser pipe coupling of well 37 is also shown on plate 6. This well screen was sheared off less than 1 ft below the coupling during removal from the ground. The break occurred along a circumferential row of perforations which formed a weak zone. There is no evidence of appreciable chemical attack on the recovered portion of the well screen, although some slight attack may be indicated by the presence of asbestos fibres which have been freed from the cement matrix. The interior of this screen was free of incrustation, but showed iron stains. The roughness which is evident in the photograph of the interior is due to chips forced out by the drill during perforation of the cement-asbestos pipe.

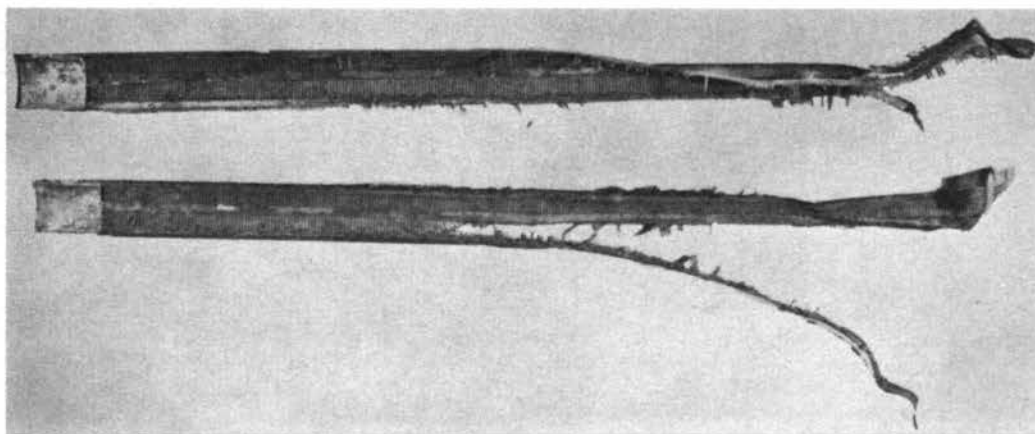
22. Several of the destructive effects of corrosion are emphasized by the close-up views shown in the photographs of plate 7. In the photograph of the slotted brass screen from well 19 the weak, brittle condition of the brass is exaggerated by damage done during dissection. However,

the difference between the condition of this screen and that of the similarly dissected one from well 33 shown in plate 6 indicates the definite loss of strength by the former. The photograph of the details of the porous concrete pipe screen of well 38 illustrates the complete disintegration which occurred. The chemical attack and leaching of the cement from the perforated concrete section of well 42 are emphasized by the exposure of the aggregate shown in the third photograph of plate 7. The final photograph of this plate illustrates the complete corrosive destruction of the recovered portion of the 20-gage galvanized sheet steel section of well 48 of the experimental system.

26. A sample of the roughened, brittle brass from the screen section of well 19 at Station 106+55 and a control sample from one of the wells which showed no sign of corrosive disintegration were analyzed quantitatively to determine the relative proportions of zinc and copper in the corroded and uncorroded material. This analysis was made for the purpose of verifying the conclusion drawn from the rough brittle condition of the corroded brass as to the nature of the corrosion. The evidence of roughness and brittleness indicated a process of selective corrosion known as dezincification in which chemical attack on the brass causes the zinc and copper to go into solution. The copper is redeposited from solution as a spongy amorphous mass of metal at the site of the corrosion and the zinc remains in solution and is carried off. The control sample from an apparently uncorroded well screen, which was only slightly discolored, showed a typical yellow brass color when scrubbed with a stiff brush and was ductile. No analysis of the brass used in the well screens was available; however it was thought likely that it was common yellow brass in which the nominal content of zinc and copper are 34 per cent and 66 per cent, respectively. This conclusion was verified by analysis of the control specimen, which gave 65.79 per cent copper and 33.83 per cent zinc. The remainder, 0.38 per cent, is probably impurities. Analysis of the specimen from well 19 gave 65.50 per cent copper and 30.68 per cent zinc. The 3.82 per cent remainder is thought to be due to fine soil particles which were trapped in the porous mass of redeposited copper and could not be removed by washing or brushing. The loss of zinc verifies the assumption of the dezincification process.

WELL 19. DISSECTED SLOTTED BRASS WELL SCREEN

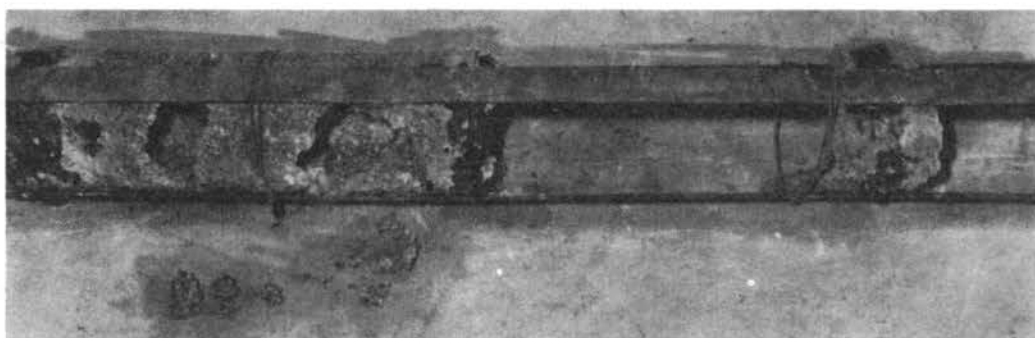
WELL 38. POROUS CONCRETE PIPE WELL SCREEN

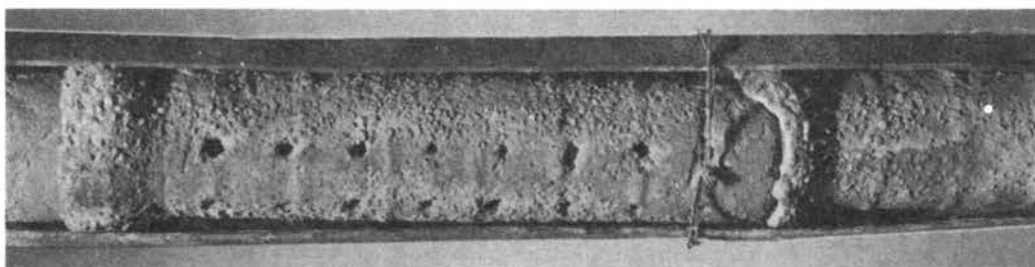
WELL 42. PERFORATED CONCRETE PIPE WELL SCREEN

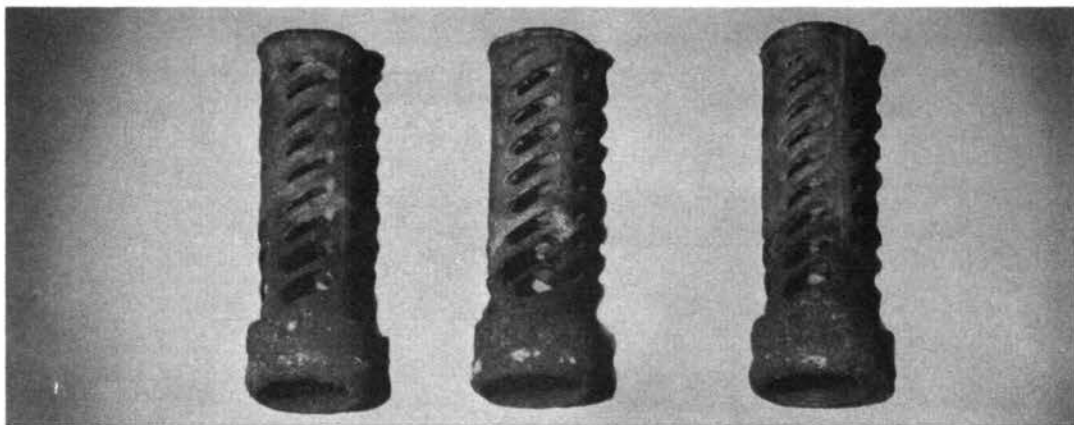
TYPICAL STRAINER CAPS

23. Corrosion of typical wells from the original well system is illustrated by the photographs of plate 8. The strainer caps which were placed at the top of each well to prevent the entrance of foreign bodies which might obstruct the well were galvanized cast iron. These caps, illustrated in the first photograph of this plate, showed very heavy corrosive attack in the portions which were subject to flow of the well water, but were evidently undamaged over that portion which was exposed only to the atmosphere. The corrosion of these strainer caps was uniform with no indication of pitting. The type of corrosion which was found to be characteristic of the extreme south end of the well system is illustrated by the photograph of well 3 (original well system) at Station 110+55. The brass of the well screen had a characteristic rough surface, was brittle and most of the slots were enlarged. The galvanized wrought-iron riser pipe showed little damage from corrosive action, the zinc coating was still present over much of its surface and the interior of the pipe was covered with only a thin uniform incrustation. Some minor

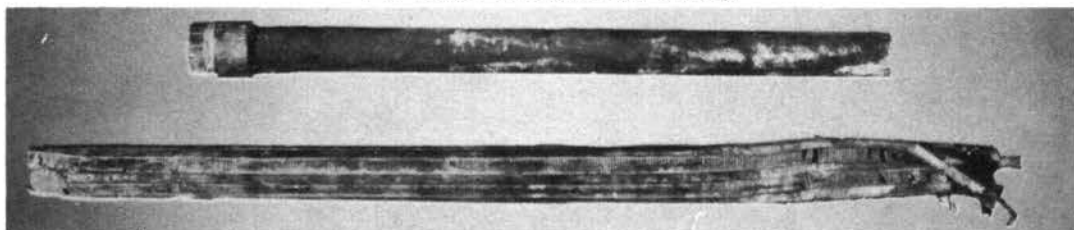
WELL 3. SOUTH END OF SYSTEM: STATION 110+55

corrosive pitting was evident on the riser pipe in the vicinity of the screen coupling. The photograph of a portion of well 58 at Station 96+80 illustrates the type of corrosive action which was general in the central portion of the original well system. Neither the brass screen nor the galvanized riser pipe shows evidence of serious corrosion. The riser pipes of the wells in this part of the system showed some evidence of corrosion directly below the ground surface, but this had not progressed to a serious degree when the wells were removed. The photograph of well 104 at Station 85+27 shows typical results of corrosive action on the wells at the north end of the system. The brass well screen was incrustated near the riser pipe joint, but otherwise showed no detrimental effects of corrosion. The riser pipe, however, had been subjected to extremely heavy corrosive attack. This attack was heaviest near the brass screen and directly below the ground surface. The corrosion showed that very extensive pitting occurred; many of the riser pipes of wells in this vicinity were perforated to the extent of nearly complete disintegration.

35. It is evident, from the photographs of typical wells from the original system shown in plate 8, that the corrosion processes which took place on these wells varied widely along the length of the system. At the south end, the brass screens were vigorously attacked, showing signs of dezincification, and the galvanized wrought-iron riser pipes had been subject to only mild corrosion. At the north end, the brass well screens showed essentially no damage from corrosion, but the riser pipes were disintegrated, in some cases beyond recovery. The central portion of the system was subject to varied attack but neither the screens nor riser pipes of the wells in this vicinity were damaged to the serious degree found near the extremities of the system. These differences in corrosion attack were not evident in the wells of the experimental system, since it was situated near the southern end of the original system and was of limited lateral extent.

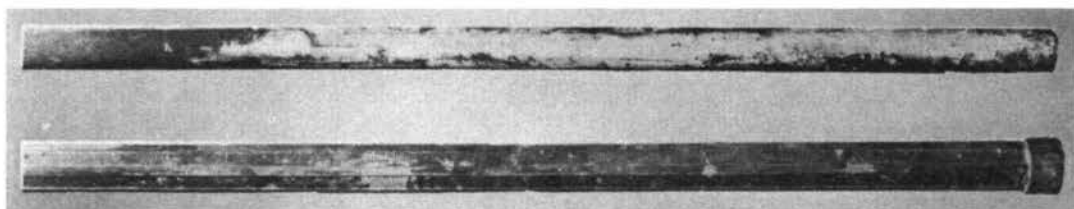
WELL 58. CENTRAL PORTION OF SYSTEM: STATION 96+80

48. It has been noted that the wells of the central part of the system were not badly damaged by corrosion, although some attack was evident on all wells. In this part of the system, the most serious damage appeared to be that which affected the brass screen sections at the riser pipe coupling, as illustrated in plate 6. This corrosion was evidently localized to the vicinity of the coupling threads and was probably due to high stresses caused by jamming the screen over the sharp threads and was probably enhanced by some galvanic corrosion.

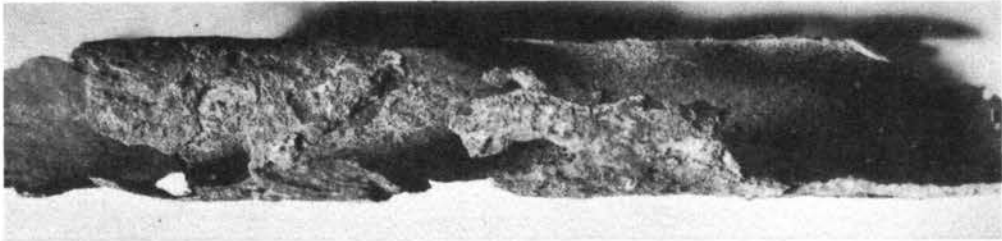
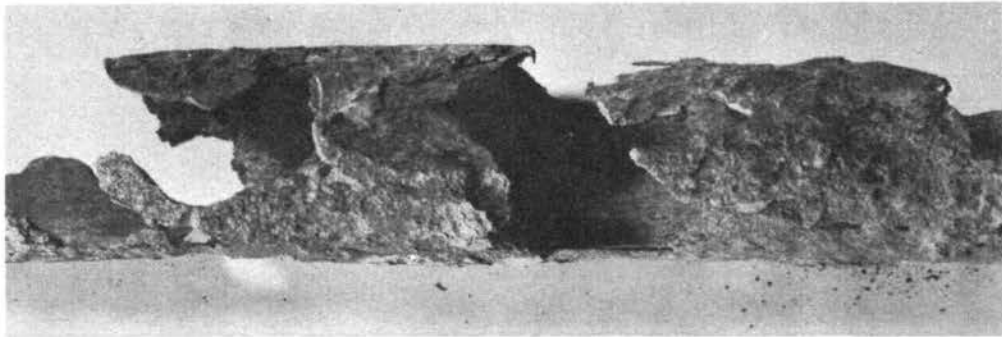
WELL 106. DETAIL OF RISER PIPE CORROSION

24. A general view of part of well 106 from the north end of the original system at Station 84+75 and details of a section of the perforated riser pipe from that well are shown in plate 9. The nature of the perforation and of the interior incrustation is shown in the photographs. The perforations appear to have resulted almost entirely from pitting of the outer surface of the pipe. Corrosion of the interior of the riser pipe appears to be uniform and to involve incrustation to a thickness of about $1/8$ in. A portion of the multilayer incrustation which also occurred on the outer surface of the riser pipes in some places is also shown on plate 9.
